NATIONAL TRANSPORTATION SAFETY BOARD

AIRCRAFT ACCIDENT REPORT

AIR FLORIDA, INC.
BOEING 737-222, N62AF
COLLISION WITH 14TH STREET BRIDGE,
NEAR WASHINGTON NATIONAL AIRPORT
WASHINGTON, D.C.
JANUARY 13, 1982

NTSB-AAR-82-8

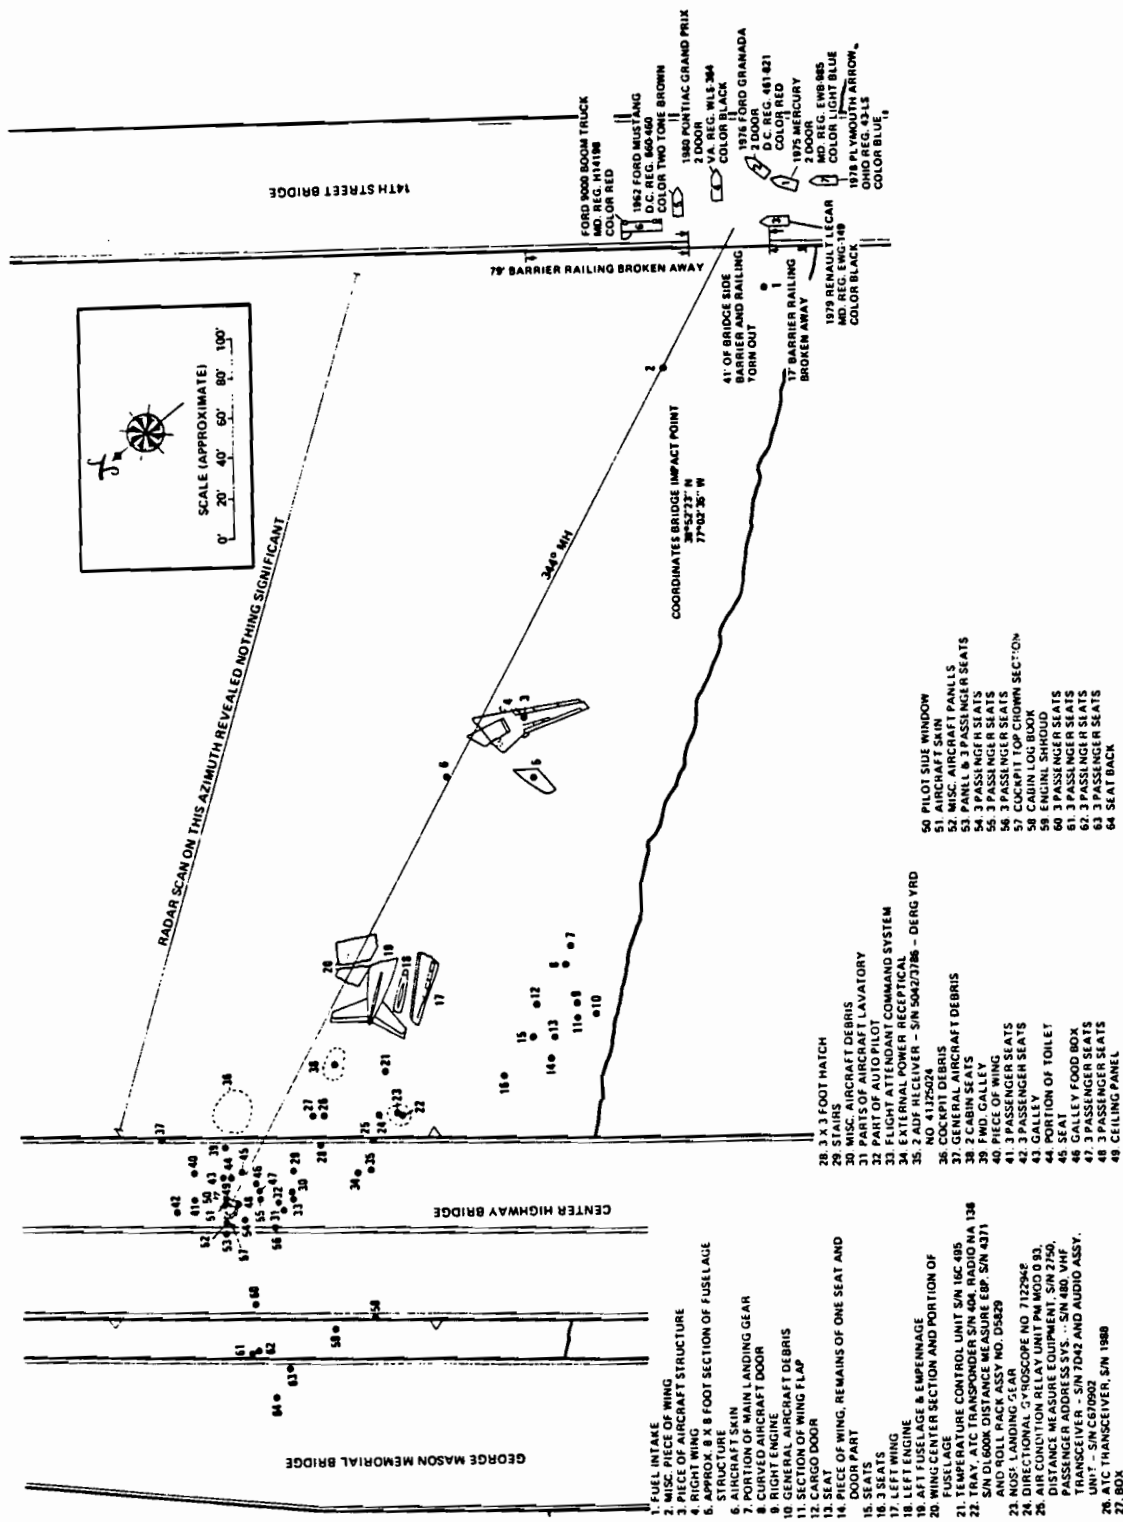
Figure 4. -- Position of Wreckage in the Water.

As the aircraft descended, the right wing was structurally damaged when it hit the boom truck, and shortly thereafter, the aircraft struck the steel barrier and railing on the west side of the 14th Street Bridge at an elevation of about 37 feet mean sea level. Fragments of the right wing remained on the bridge. The remainder of the wreckage sank in the Potomac River in about 25 to 30 feet of water. The wreckage area was confined to the south side of the river between the 14th Street Bridge and the Center Highway Bridge of the George Mason Memorial Bridge. (See figure 4.)

After initial impact, the aircraft broke into several major pieces. The fuselage broke into four major pieces which included: (1) nose section with cockpit; (2) fuselage section between nose section and wing center section; (3) fuselage-to-wing intersection; and (4) aft body structure with empennage attached. The wing structure was separated into three major pieces which included: (1) left wing outboard of the No. 1 engine, including all associated flight control surfaces; (2) wing center section, lower surface, including wing lower surface stubs between the No. 1 engine mounts and the No. 2 engine mounts; and (3) right wing outboard of the No. 2 engine with the outboard 20 feet mostly disintegrated. The left main landing gear was separated from the wing, and the right main gear remained attached except for the wheels and oleo piston. The nose landing gear and its attaching structure were separated from the nose section. Both engines and their pylon structures were separated from the wings. There was no evidence of fire on any of the recovered structure.

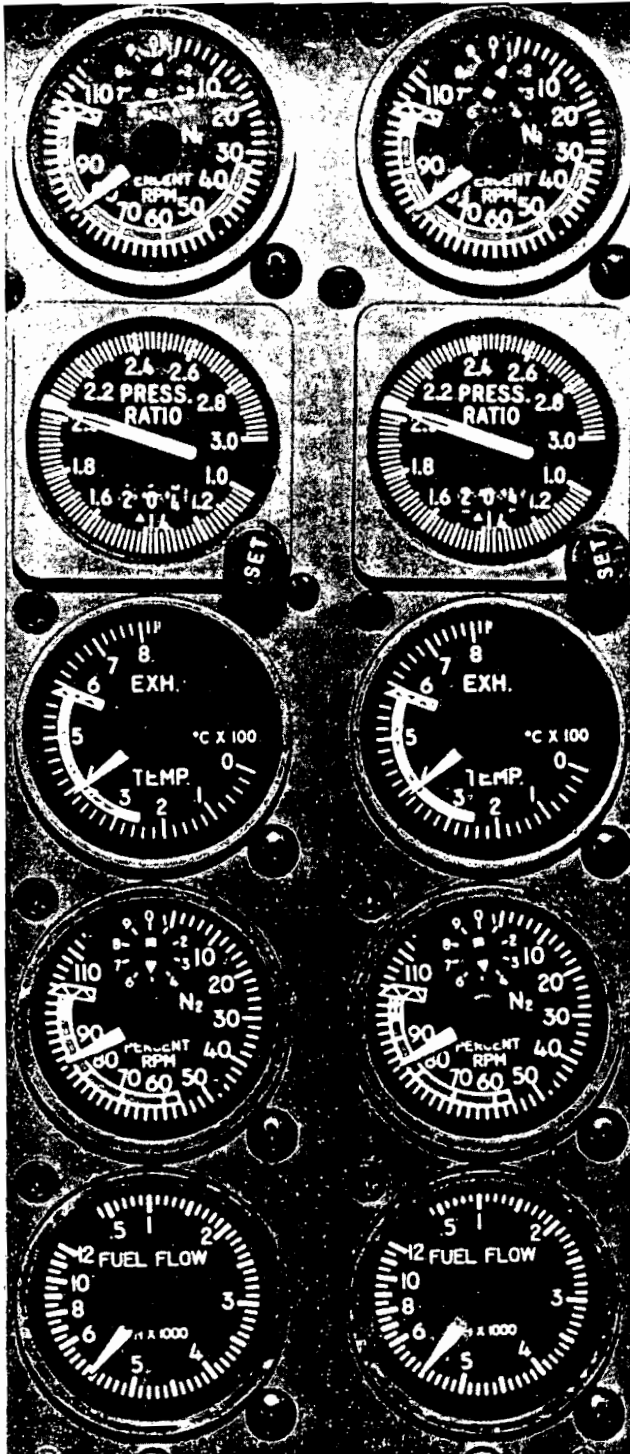
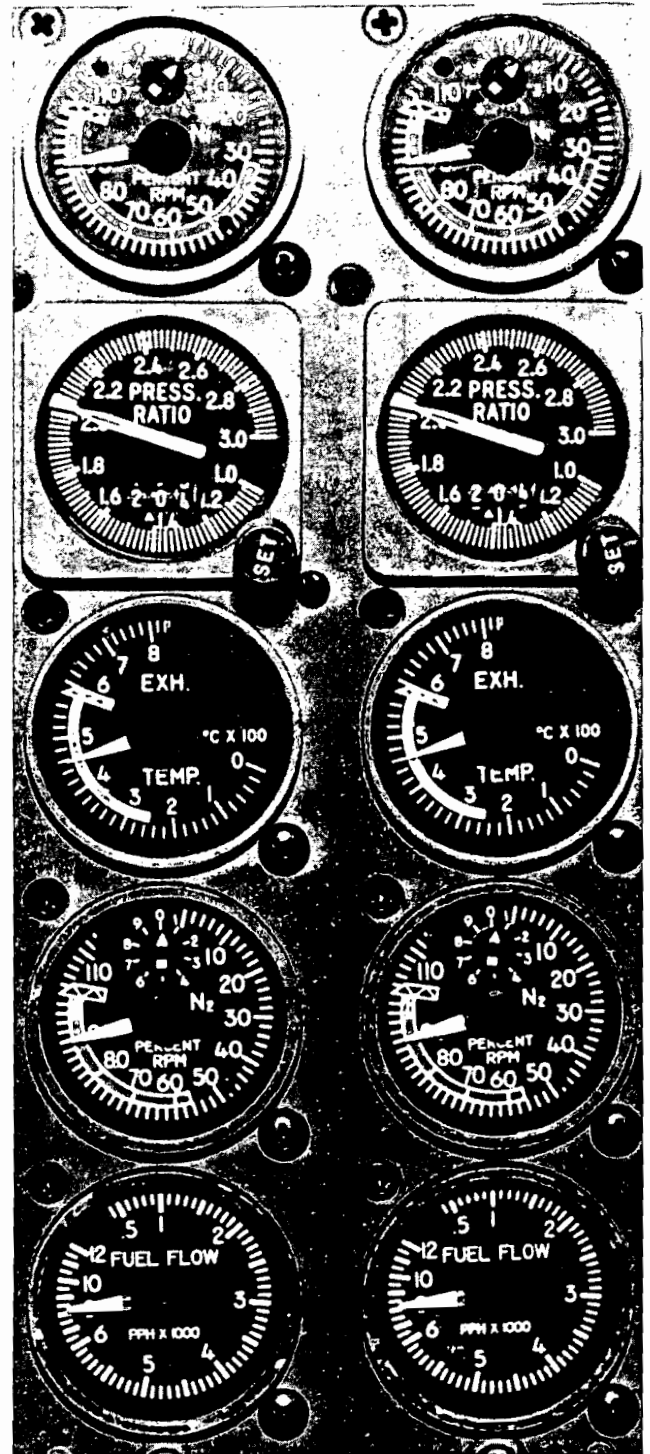
Figure 6.—Comparison of Instrument Readings -- 1.70 EPR vs. 2.04 EPR.

Engine Instrument Indication:
1.70 EPR P_{t2} probe blocked
Engine anti-ice-Off

Engine Instrument Indication:
2.04 EPR
Normal Operation

With the engine operating, a false indication of the actual EPR can be indicated in the cockpit when ice blocks the inlet probe. Under this condition, the Pt_2 probe is vented to the nose cone pressure through a siphon-break hole in the sense line. The interior of the engine nose cone is vented to the engine inlet static pressure, which is lower than the engine inlet total pressure normally sensed by the Pt_2 system. Under severe icing conditions, if the engine inlet anti-icing air bleed system is shut off and the normal Pt_2 sensing port is blocked with ice, the Pt_2 sensor will sense the lower pressure at the vent port in the nose cone. The cockpit indication may become slightly erratic as icing begins to block the probe and will indicate a significantly higher reading when ice fully blocks the probe. Tests have demonstrated that with a blocked probe at takeoff, engine power can indicate an EPR of about 2.04 with the engine actually operating at an EPR ratio of 1.70. Under these circumstances, a pilot would unknowingly attempt takeoff at a considerably lower thrust than desired. However, the pilot has available other indications of engine operation displayed in the cockpit, such as a lower N_1 , N_2 , EGT, and F/F consistent with the reduced engine thrust. (See figure 6.)

Should the pilot activate the engine inlet anti-icing system with a blocked probe, he would immediately notice a substantial drop in the indicated EPR, incorrectly indicating a low engine thrust as long as the normal Pt_2 sensing port remains blocked. This results from the introduction of engine anti-icing air flow into the nose cone and resultant increase in the pressure in the interior of the nose cone. This pressure is higher than that which would be sensed at the normal Pt_2 port. Falsely low indicated EPR's have been detected by pilots when they found that they were unable to set takeoff power without exceeding redline N_1 , N_2 , and EGT.
