NATIONAL TRANSPORTATION SAFETY BOARD

AIRCRAFT ACCIDENT REPORT

AIR FLORIDA, INC.
BOEING 737-222, N62AF
COLLISION WITH 14TH STREET BRIDGE,
NEAR WASHINGTON NATIONAL AIRPORT
WASHINGTON, D.C.
JANUARY 13, 1982

NTSB-AAR-82-8

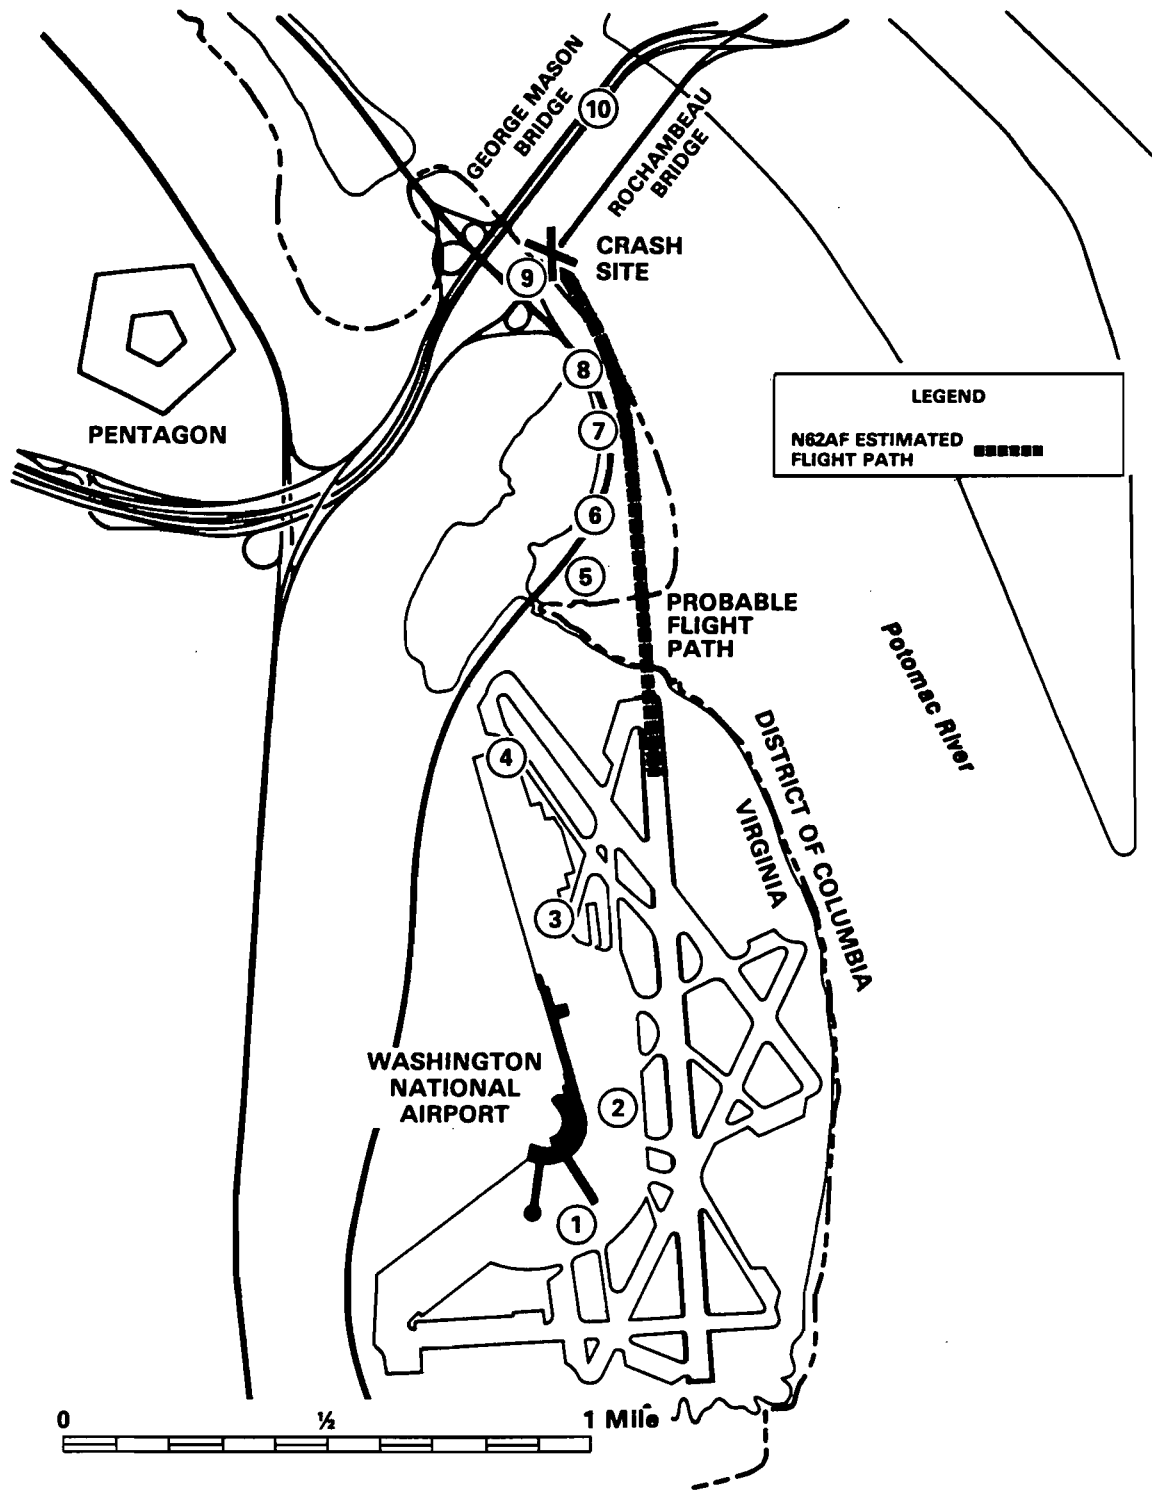
Figure 1.—Flightpath and witness locations.

Safety Board investigators interviewed more than 200 witnesses to establish the sequence of events from the start of the takeoff until impact, and more than 100 written statements were obtained. (See figure 1 for witness locations and flightpath. Numbers correlate to the locations of 10 of the witnesses interviewed.)

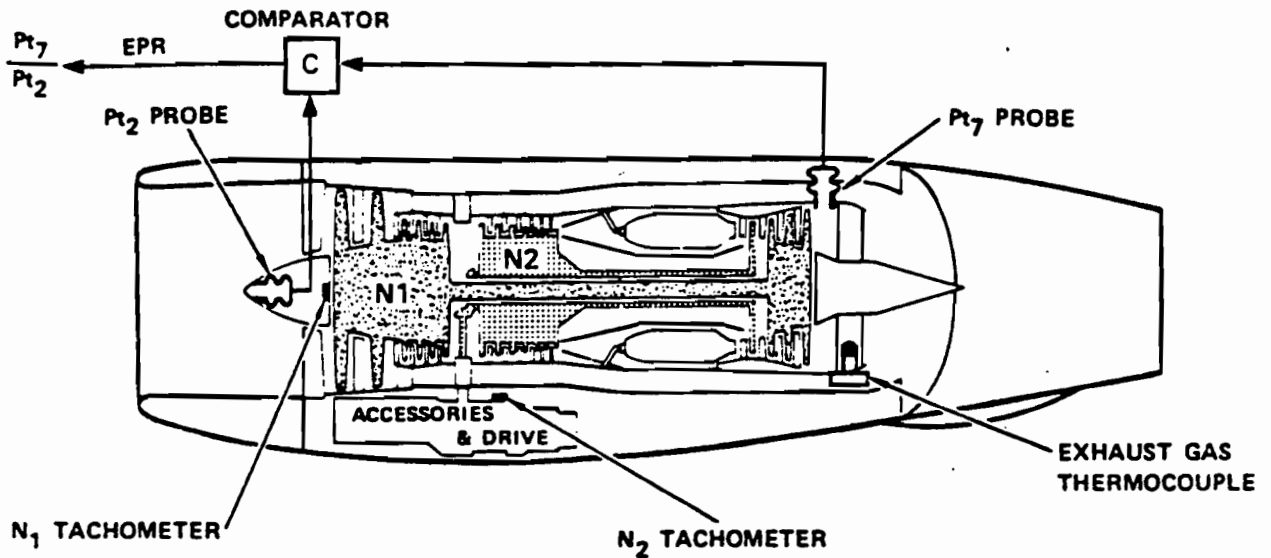
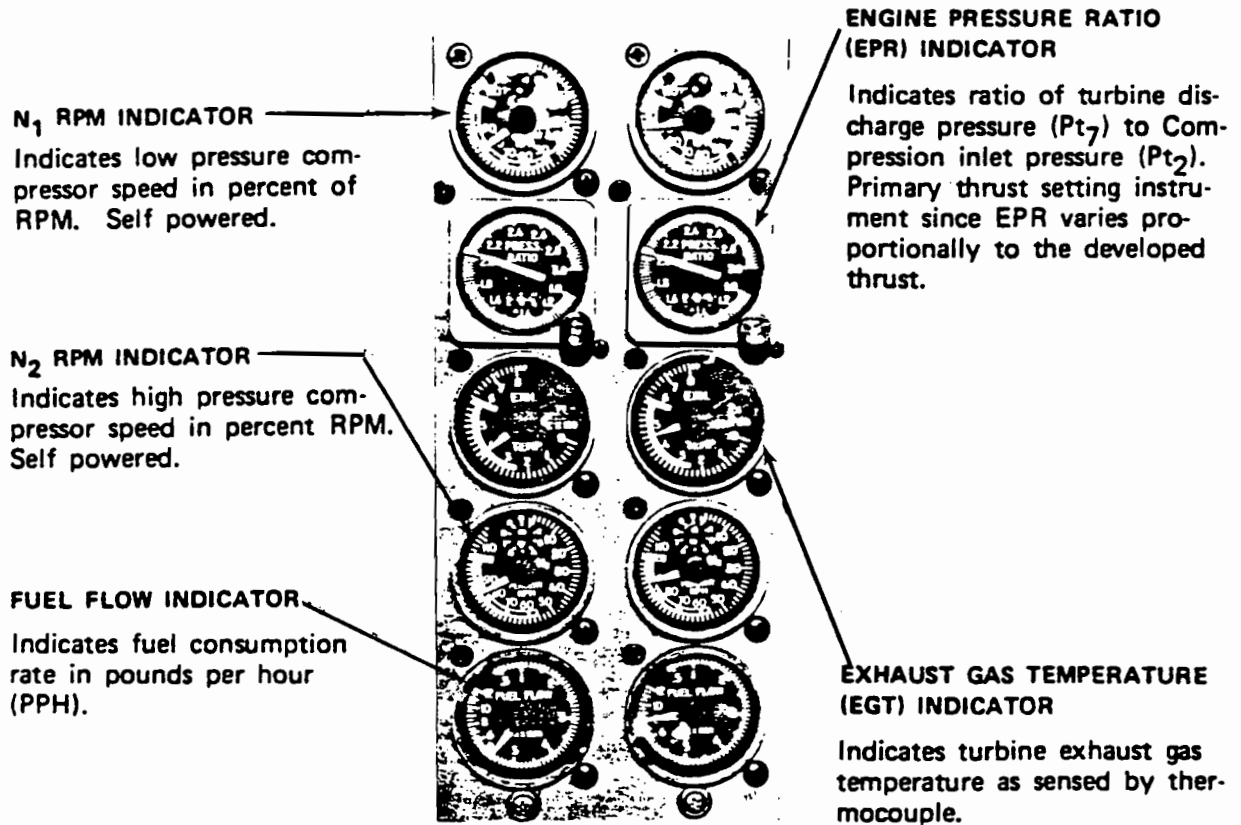
Figure 5. -- Center instrument panel functions.

The B-737's primary engine instrumentation consists of: engine pressure ratio (EPR), a direct indication of the ratio of the pressure measured at the turbine discharge pressure (Pt₇) to the pressure measured at the compressor inlet (Pt₂); the first stage fan or low pressure compressor speed (N₁); the high pressure compressor speed (N₂); the exhaust gas temperature (EGT); and the fuel flow (F/F). (See figure 5.)

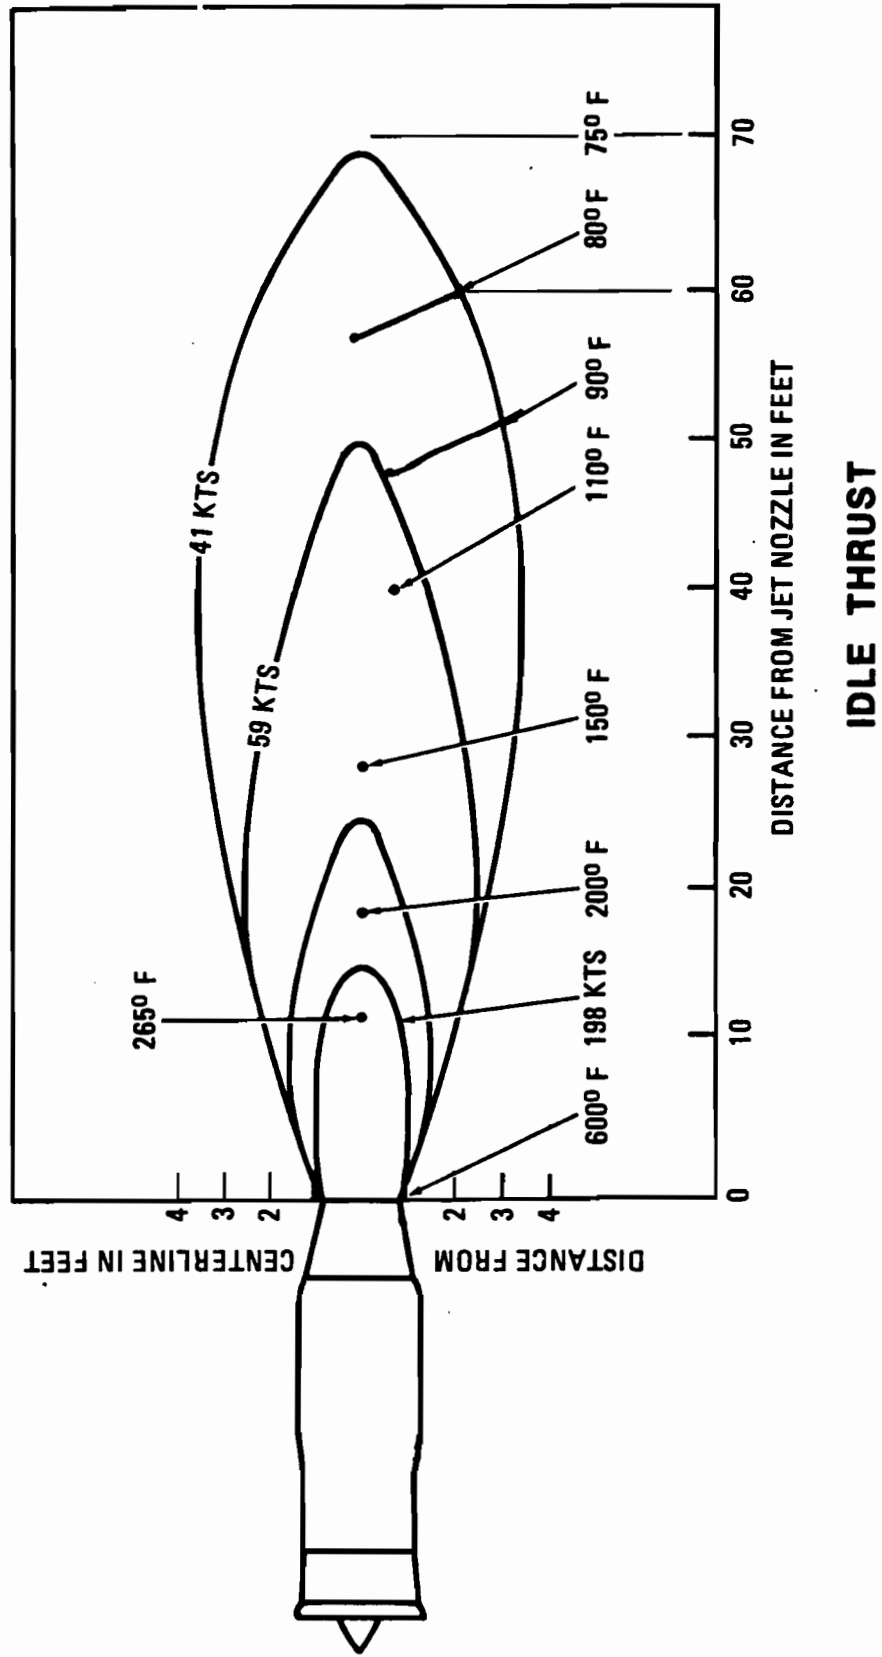
Figure 7.—JT8D turbofan exhaust gas temperatures and velocities.

Jet exhaust temperatures and velocities at given distances and power setting behind the exhaust nozzles of JT8D turbofan engines were determined to provide an indication of their effects on following aircraft. (See figure 7.)
